## ASSESSING COMMUNITY PERCEPTION OF POST-MINE BROWNFIELD'S EFFECT ON THE SOCIAL ENVIRONMENT AND VISUAL QUALITY OF URBAN LANDSCAPES IN KISUMU CITY, KENYA

**Keywords:** *Community perception, Degraded landscapes, Post-mine brownfields, Social environment, Visual quality, Urban landscapes, Spatial planning, Kisumu City Kenya,*

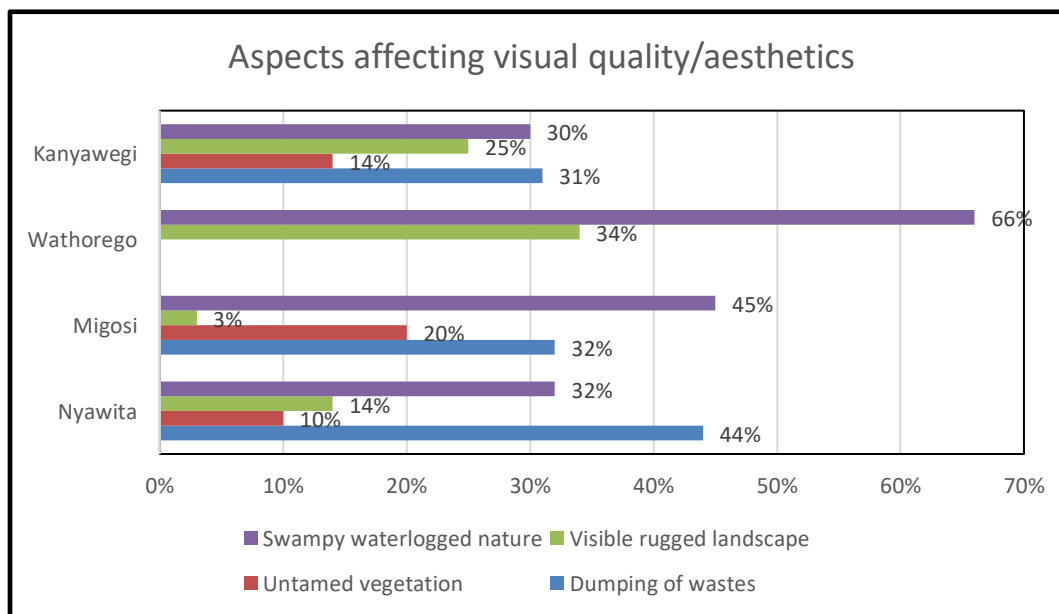
Figure 2 Aspects affecting visual quality/aesthetics within the four post-mines.

The aspects that affected the visual quality/aesthetics for the four post-mine brownfield sites was considered in terms of water logging, visible rugged landscape, untamed vegetation and dumping of wastes. Figure 2 below summarizes the results.

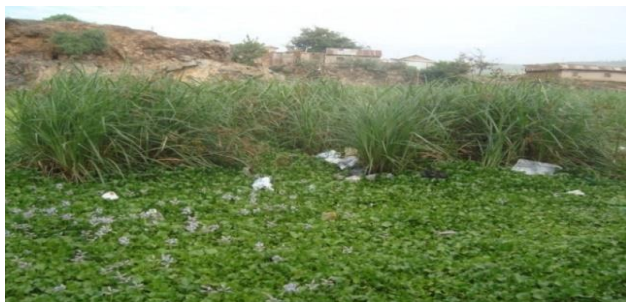
Plate 1: Swampy waterlogged area next to the Nyawita brownfield entry point.

dumping of wastes was considered by 44% of the respondents to be affecting the visual quality and aesthetic value of the immediate surroundings, while untamed vegetation was considered by 10%, visible rugged landscape by 14% and the swampy water logged nature was considered by 32% by the respondents. The 10% of the respondents who did not consider the visual quality of the post-mine to be affecting the aesthetic value in a negative way attributed this to minimal dumping of wastes by 60%, few untamed vegetation by 20% and minimal rugged landscape by 20%. None of the respondents considered the water logging to be minimal and this supported the on-site observation and site analysis that had been carried out that revealed the water logging that was evident within the shallow entry point into the post-mine. The dry parts of the quarry during the observation and site analysis also showed signs of being water logged in times of heavy rains.

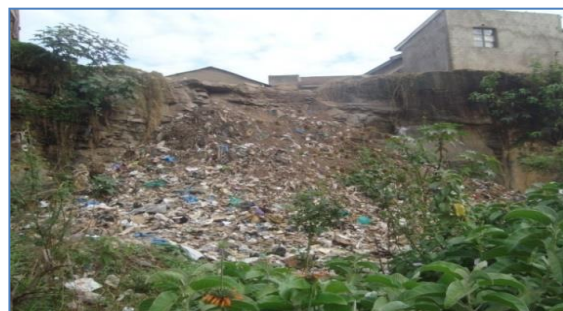
Plate 2: Dumping of household wastes on the northern side of the Nyawita brownfield.

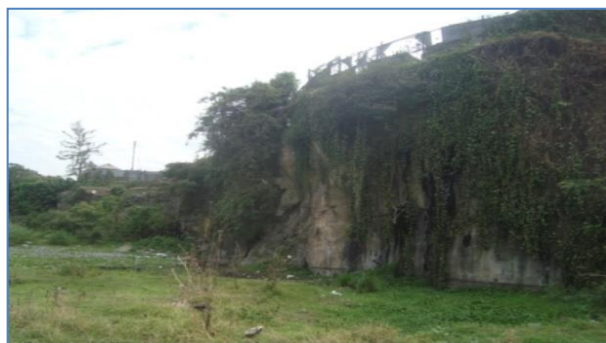
Plate 3: Quarry depth at one end & creeping vine vegetation on the rugged quarry wall at Nyawita post-mine site.

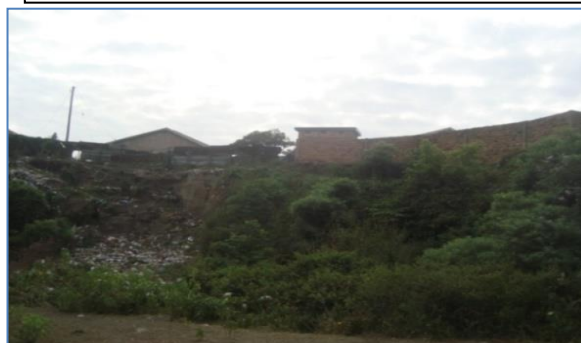
Plate 4: Untamed vegetation along the quarry wall on the southern border.

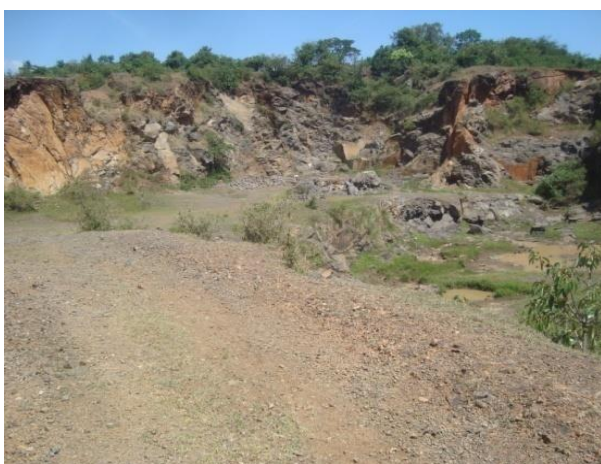
Plate 5: Rugged quarry walls at the deep end of Wathorego brownfield.  
Source: Author (2017)

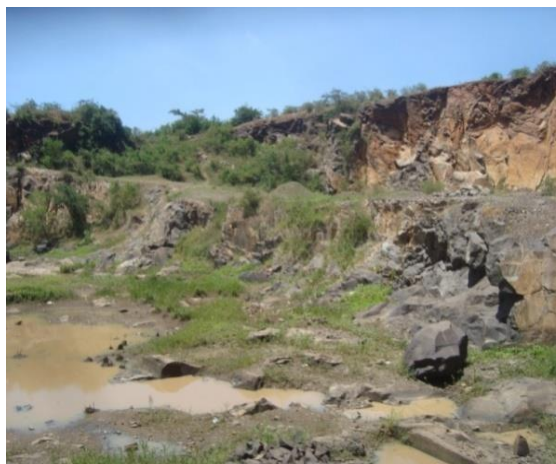
Plate 6: Water logging within the deepest end of Wathorego brownfield.  
Source: Author (2017)
